CAN 04	Colortrac Ltd	Page 1 of 1
Rev1	CopySmart v1.4l6 Profiling Issues	Date: 2009-07-06
This document intended to supplement the installation and operation manual or training

IT8 Positioning and Loading Changes

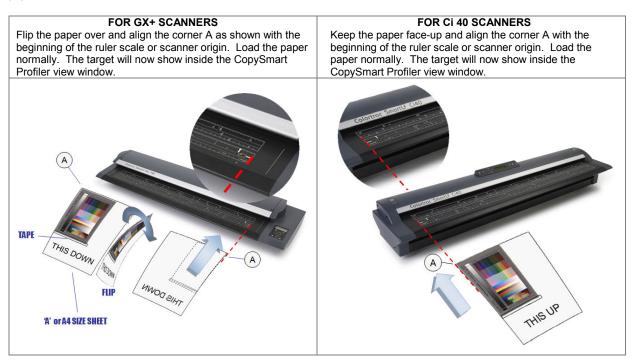
For all scanners the IT8 target needs to be mounted on a single sheet of A or A4 copier paper with the top left corner of the IT8 target (nearest the Colortrac logo) directly over the corner of the paper. Tape the IT8 target along its entire lower edge using ordinary office self-adhesive tape or similar (see picture). Do not use glue or permanent method to fix the IT8 target to the paper.

CopySmart v1.4l6 users with SmartLF Gx+ 28 and Gx+ 42 series scanners must scan the IT8 target during scanner profiling at the **scanner zero** or **origin line** - not in line with the #2 arrow as directed by the wizard. This is a temporary issue that will be fixed in the next release of CopySmart software. Follow the instructions below.

CopySmart users with SmartLF Ci 40 may find that the IT8 target becomes trapped inside the scanner during the loading process. Follow the instructions below to overcome this problem.
